Advance Funding Agreement

CSJ 0922-33-133

Bridge at Lincoln Road at Becerra Creek 17.6 mi north of US 59

NBI Structure # [222400AA0112003](#); is approximately 17.3 to 17.6 miles north from US HWY 59

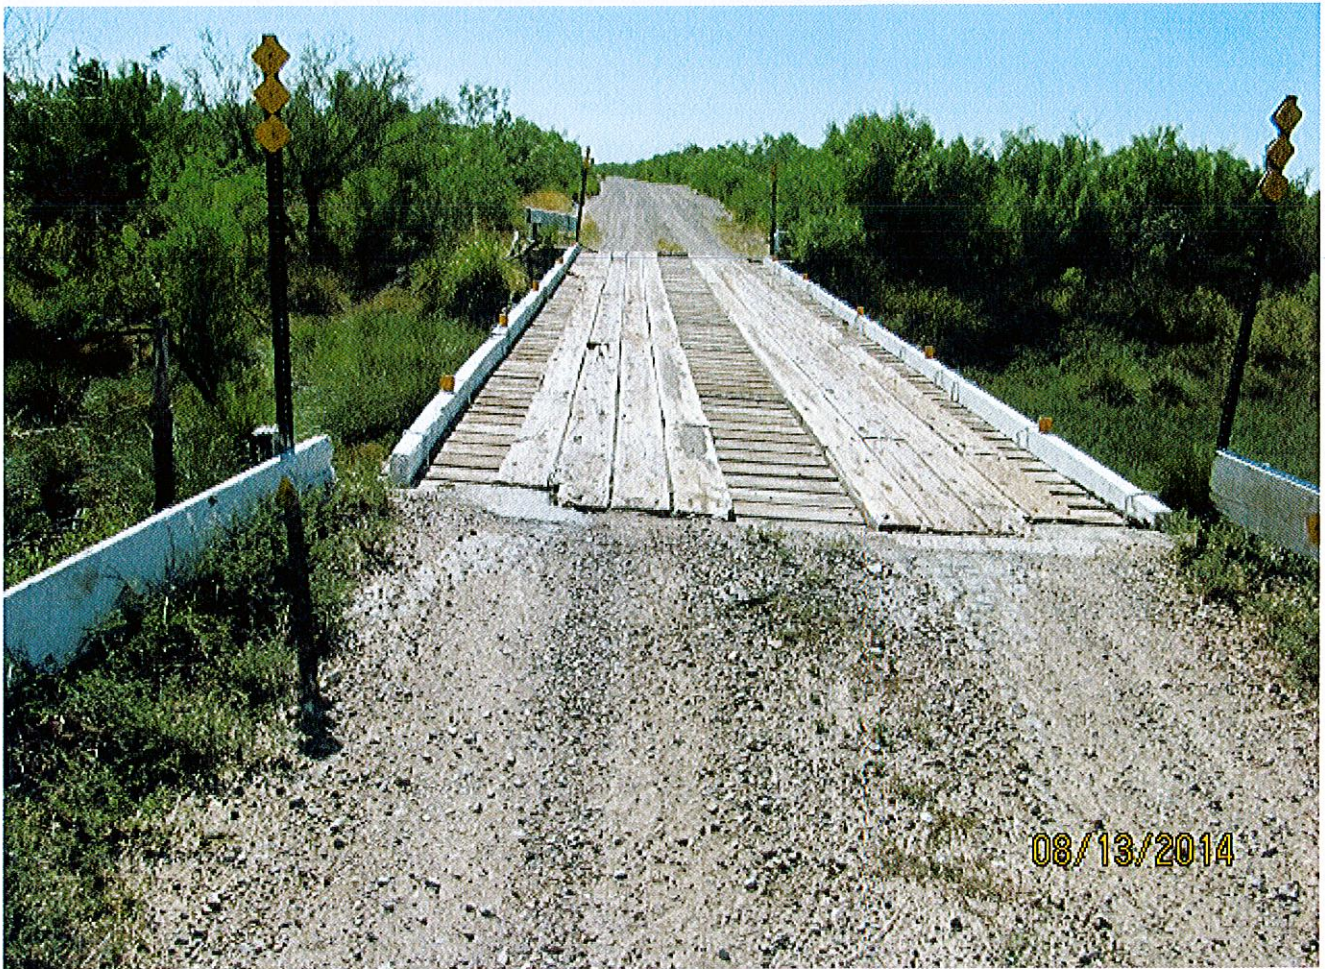
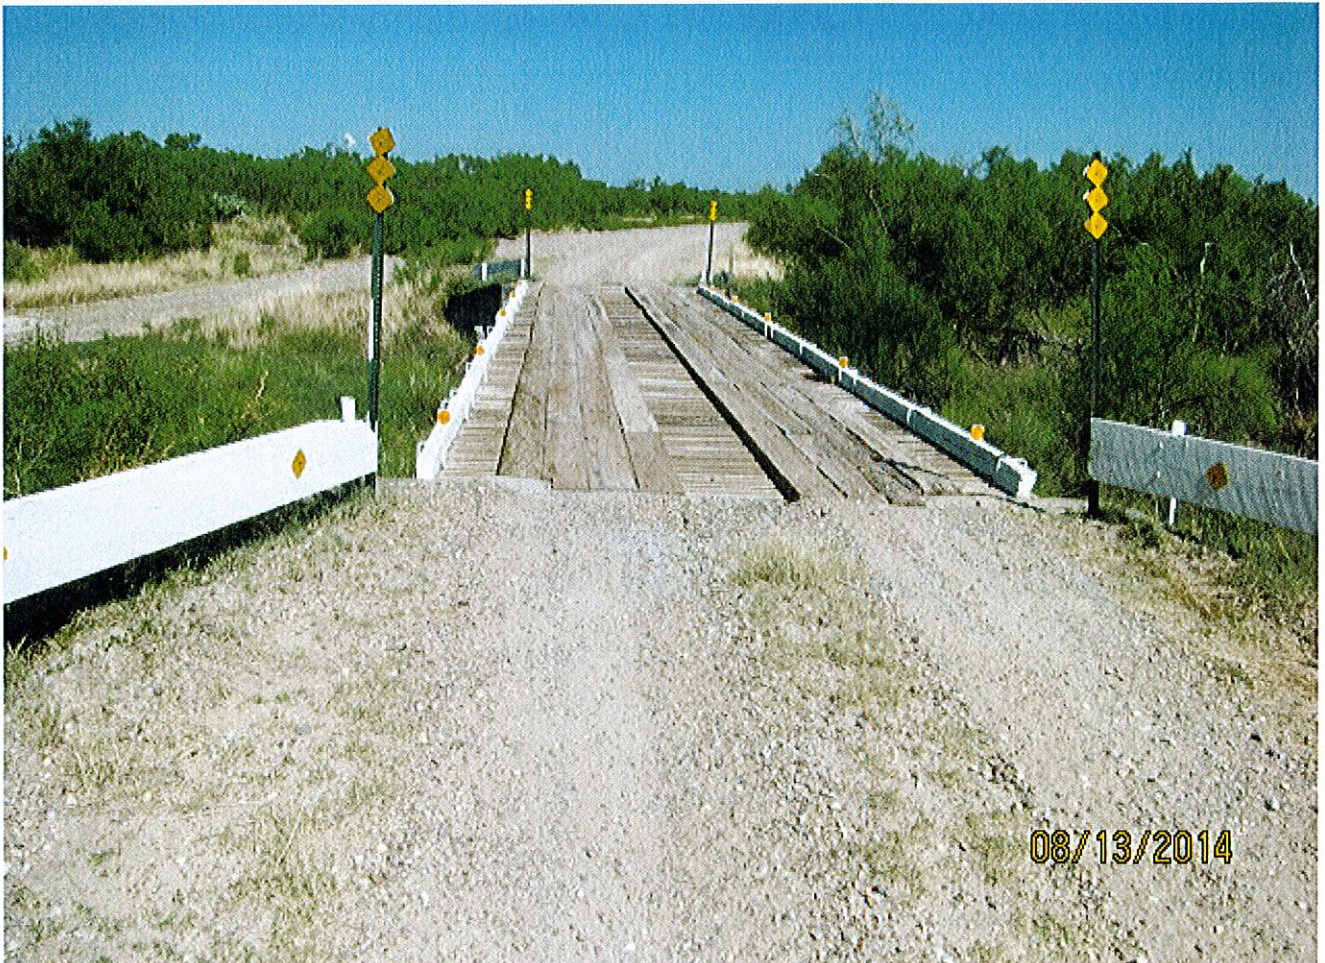
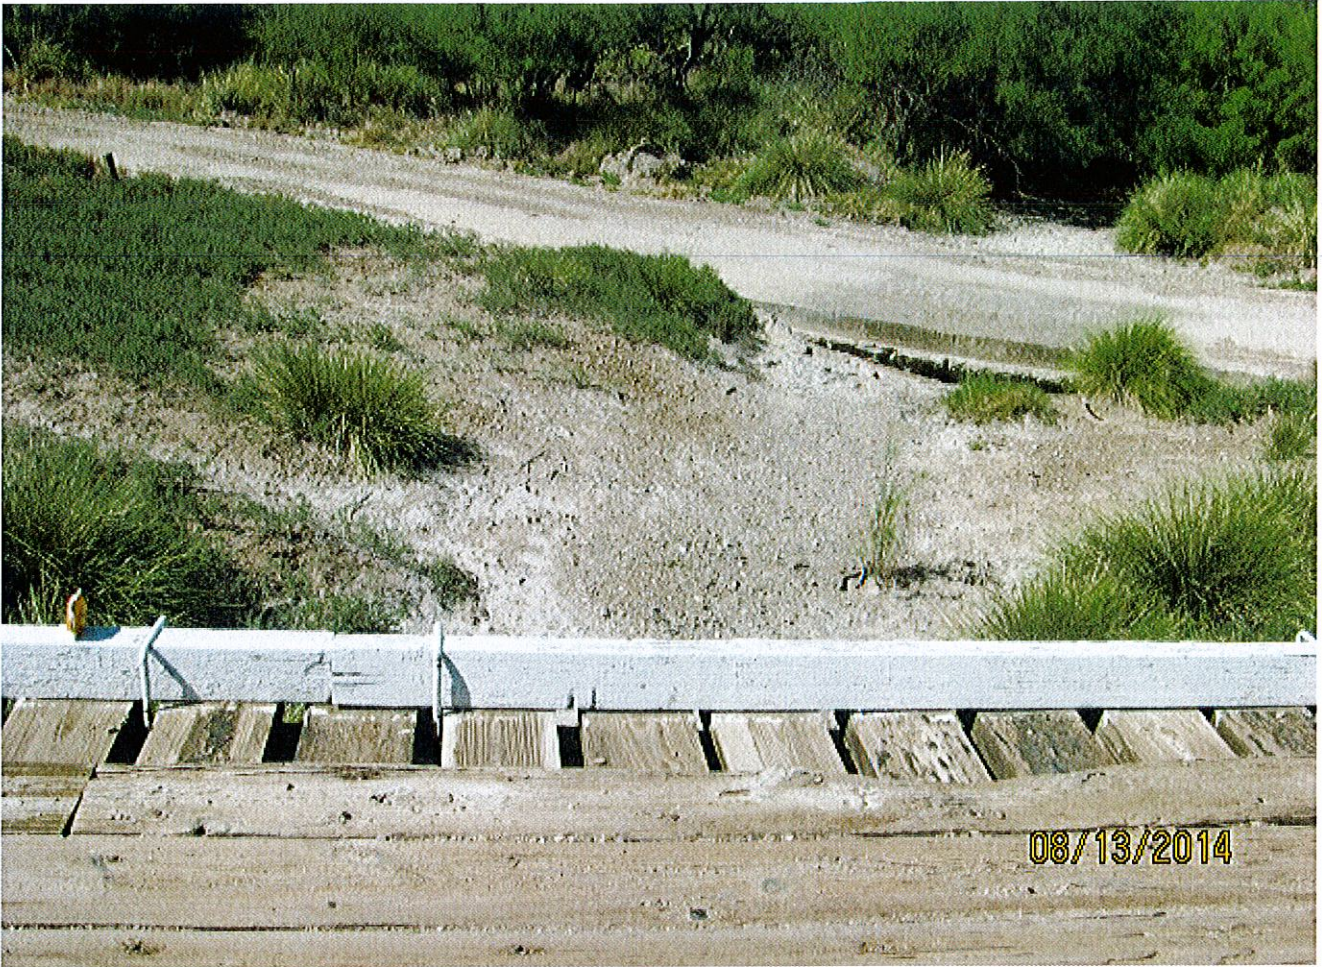
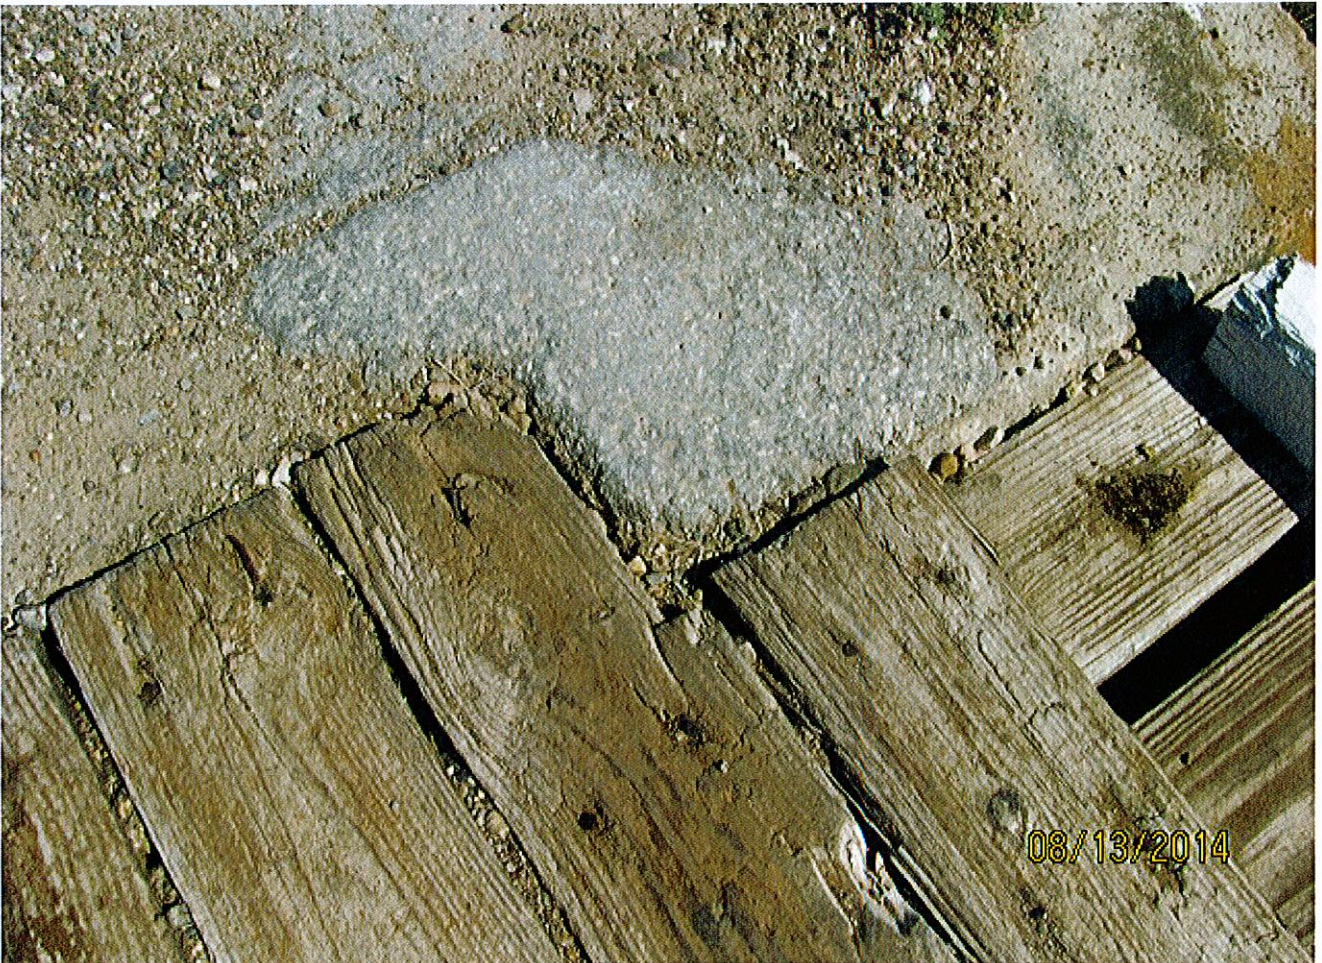
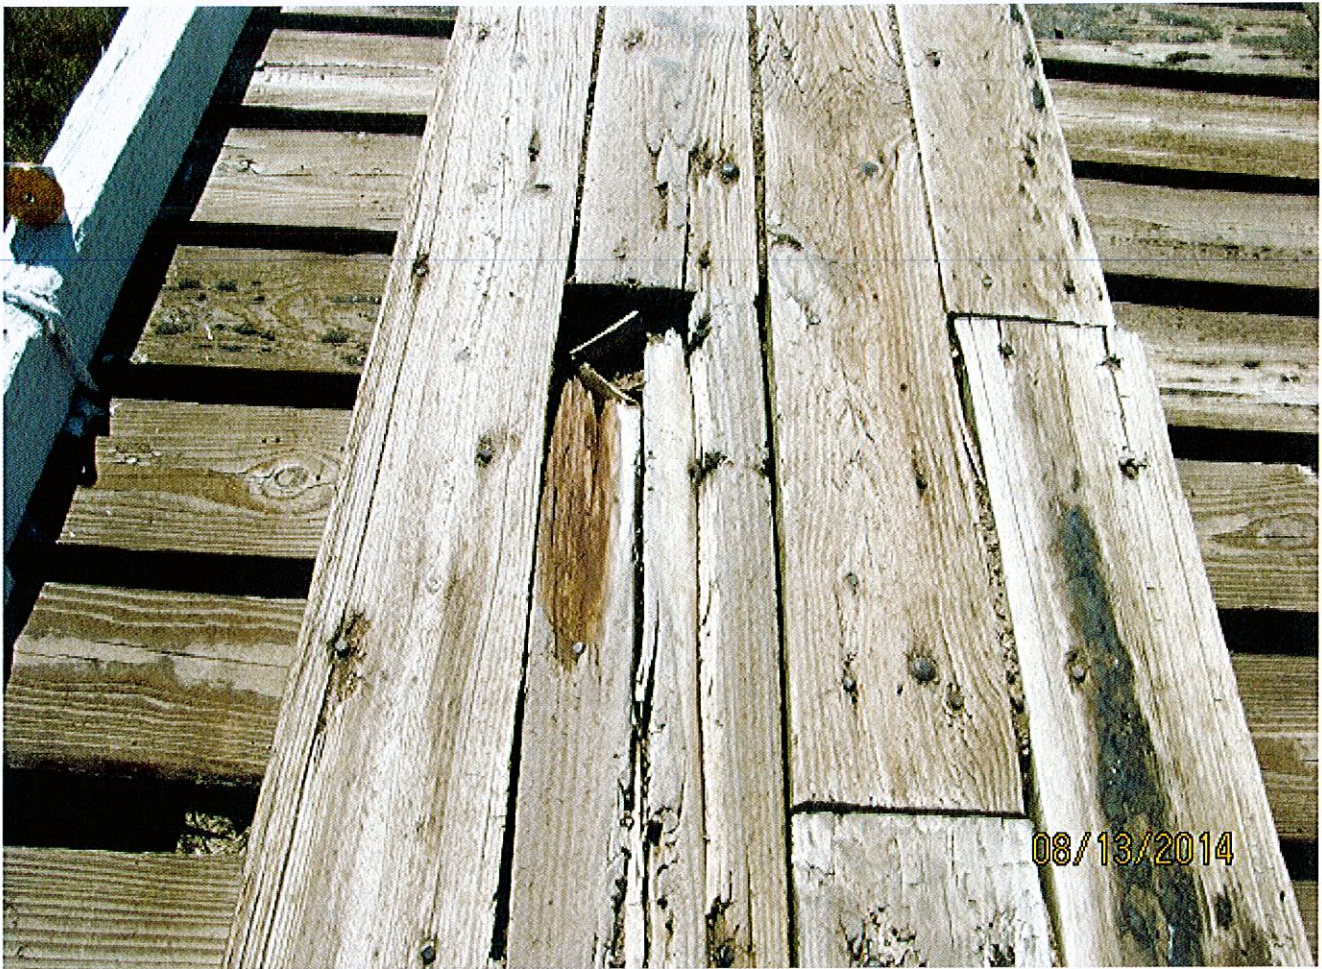
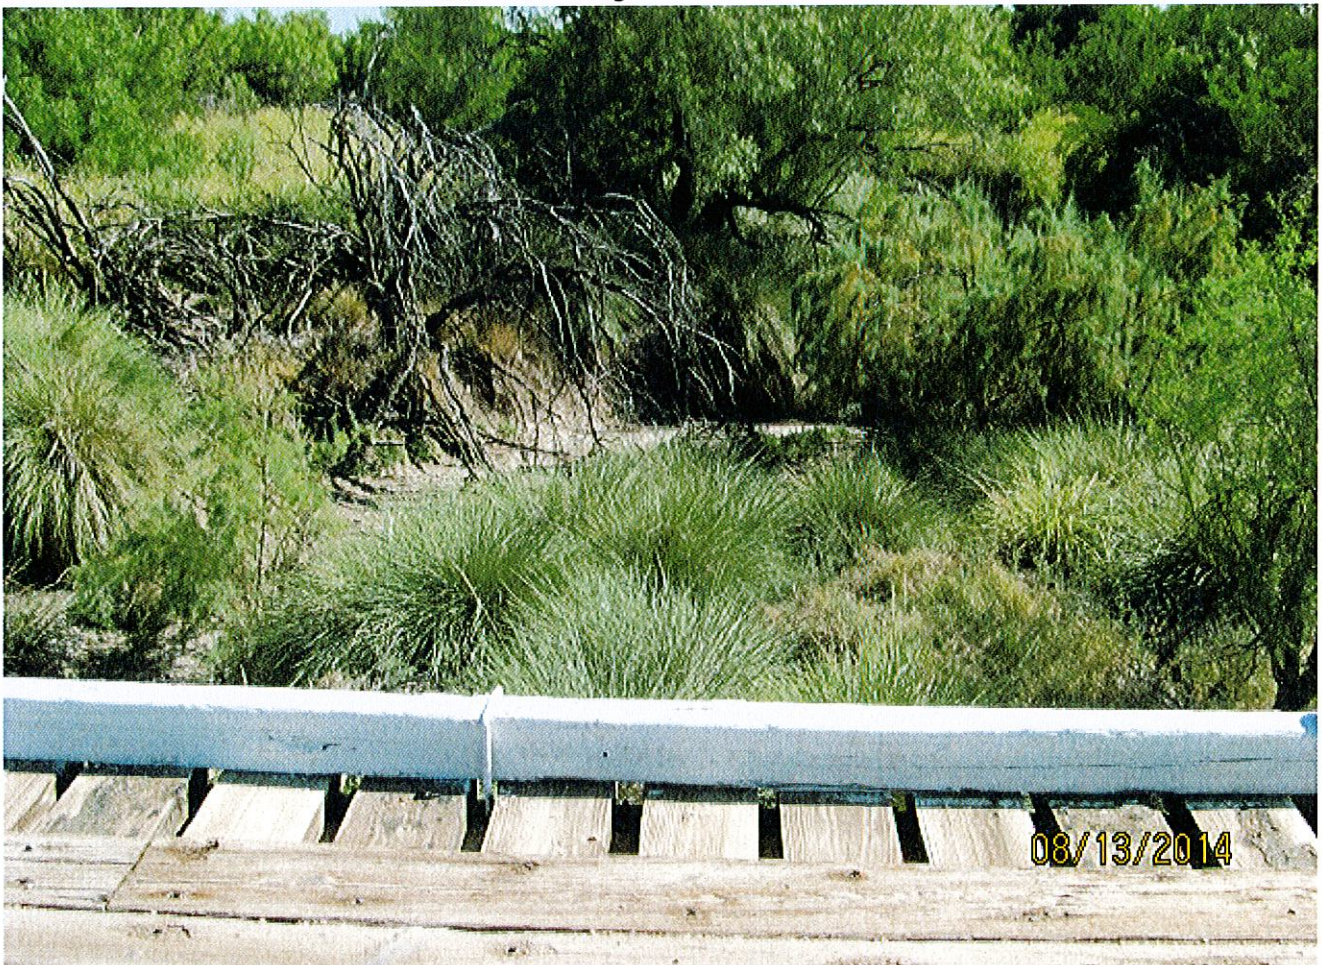
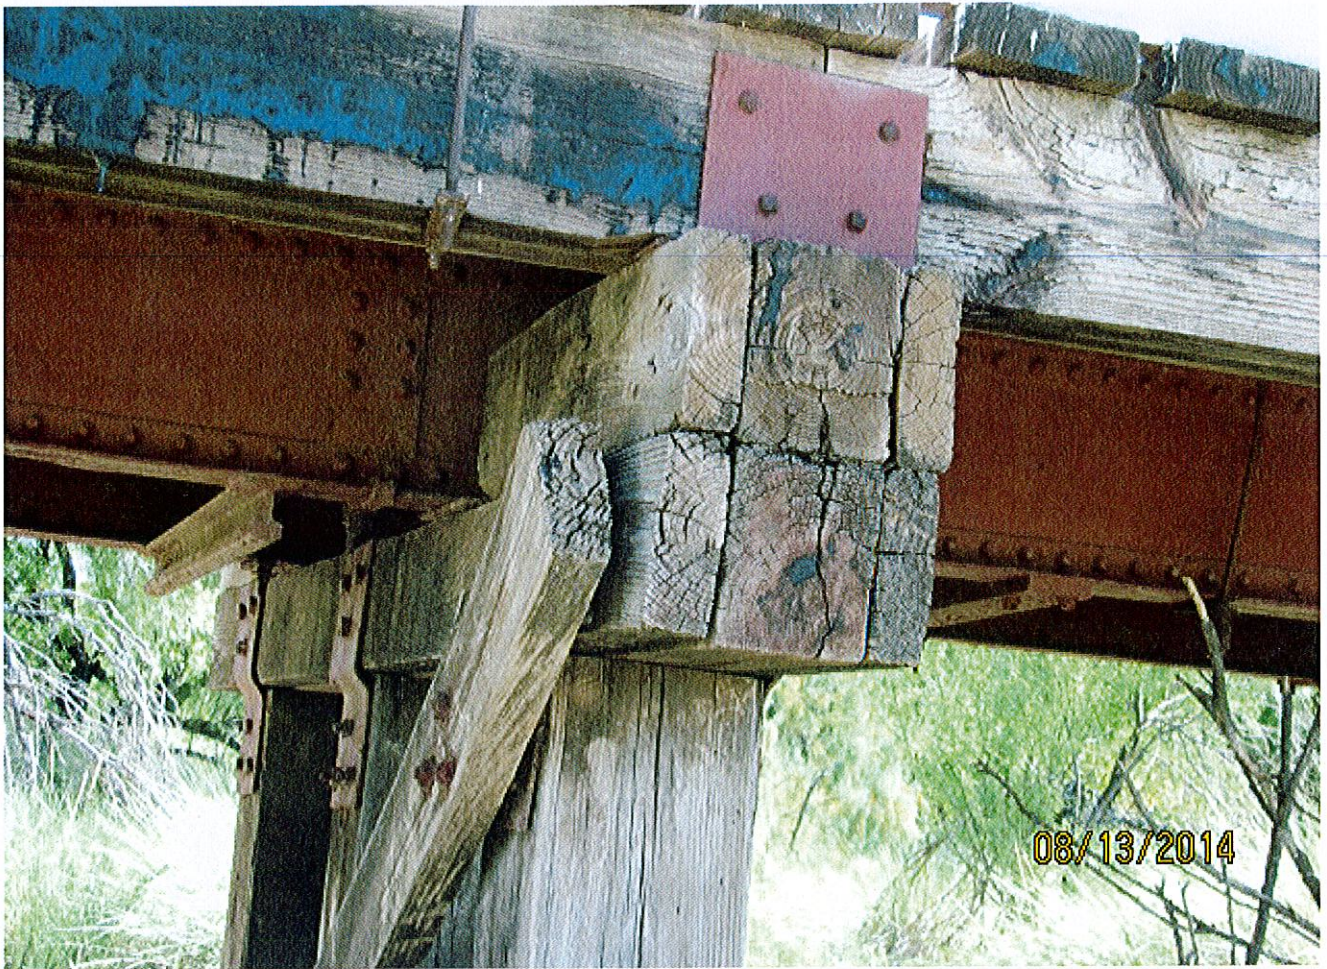
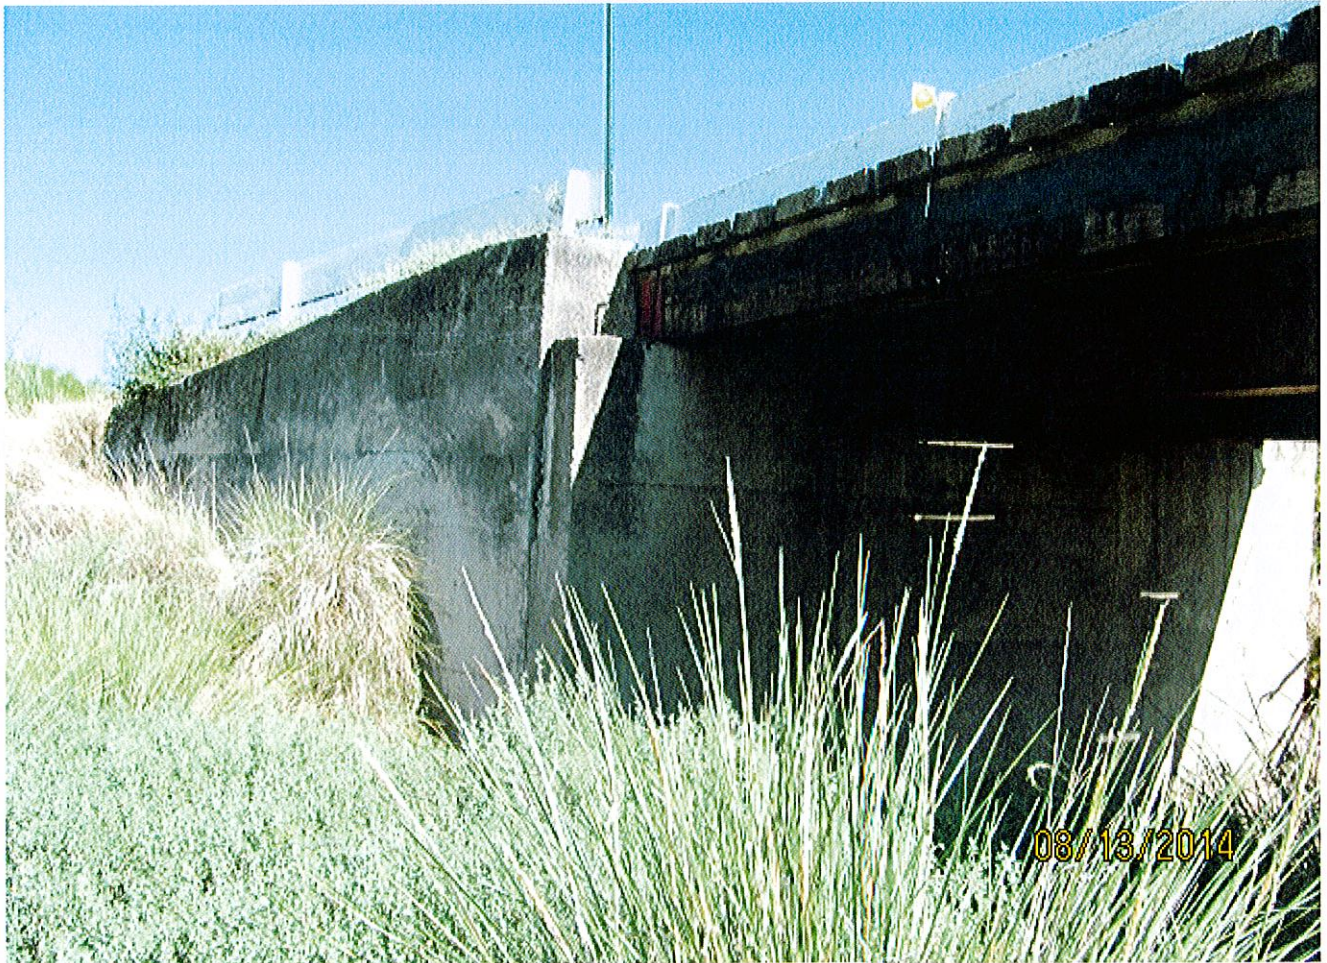
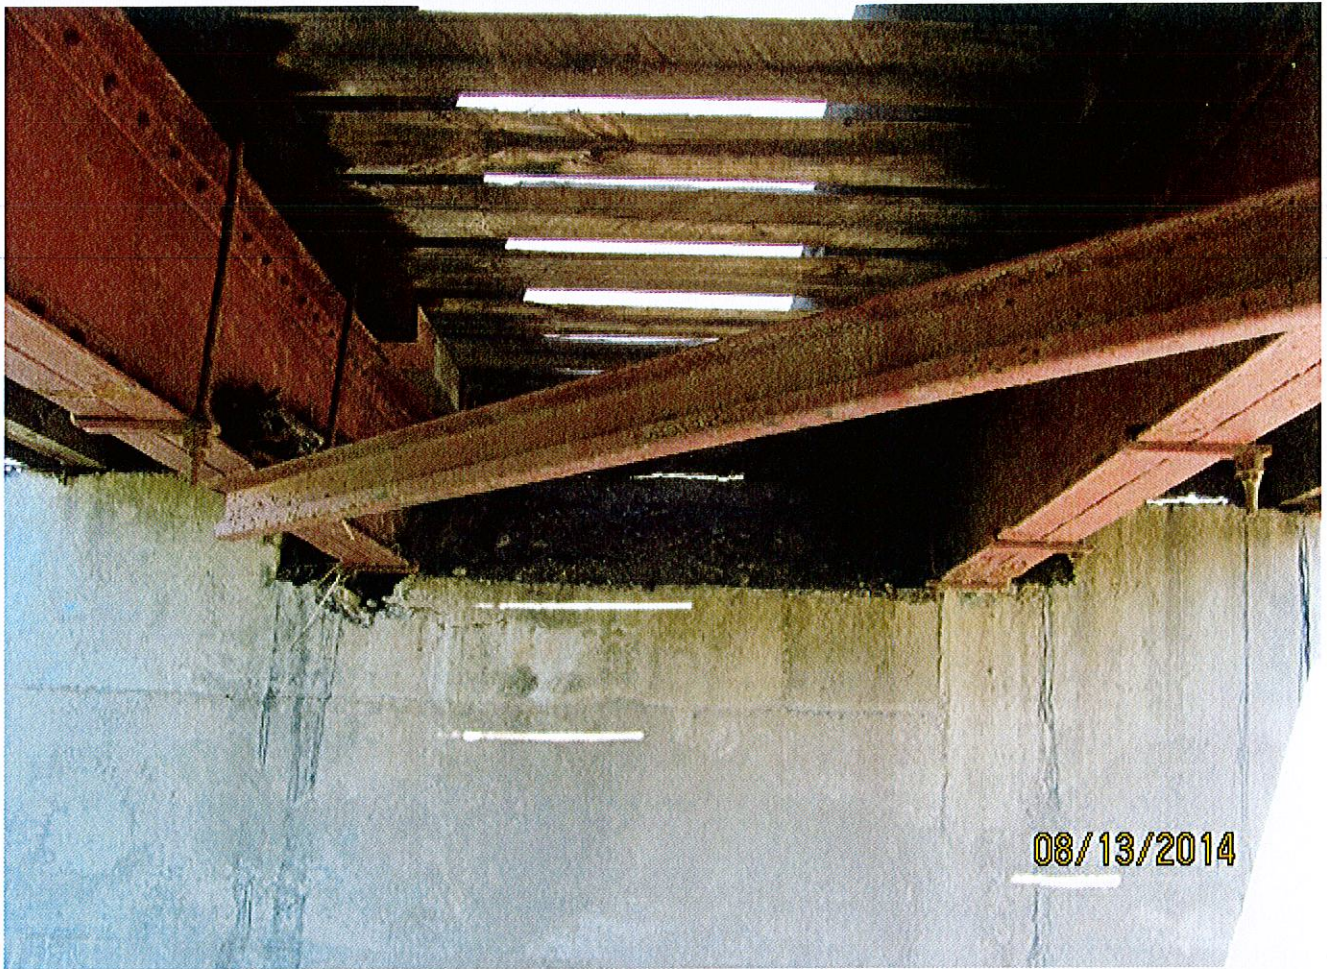
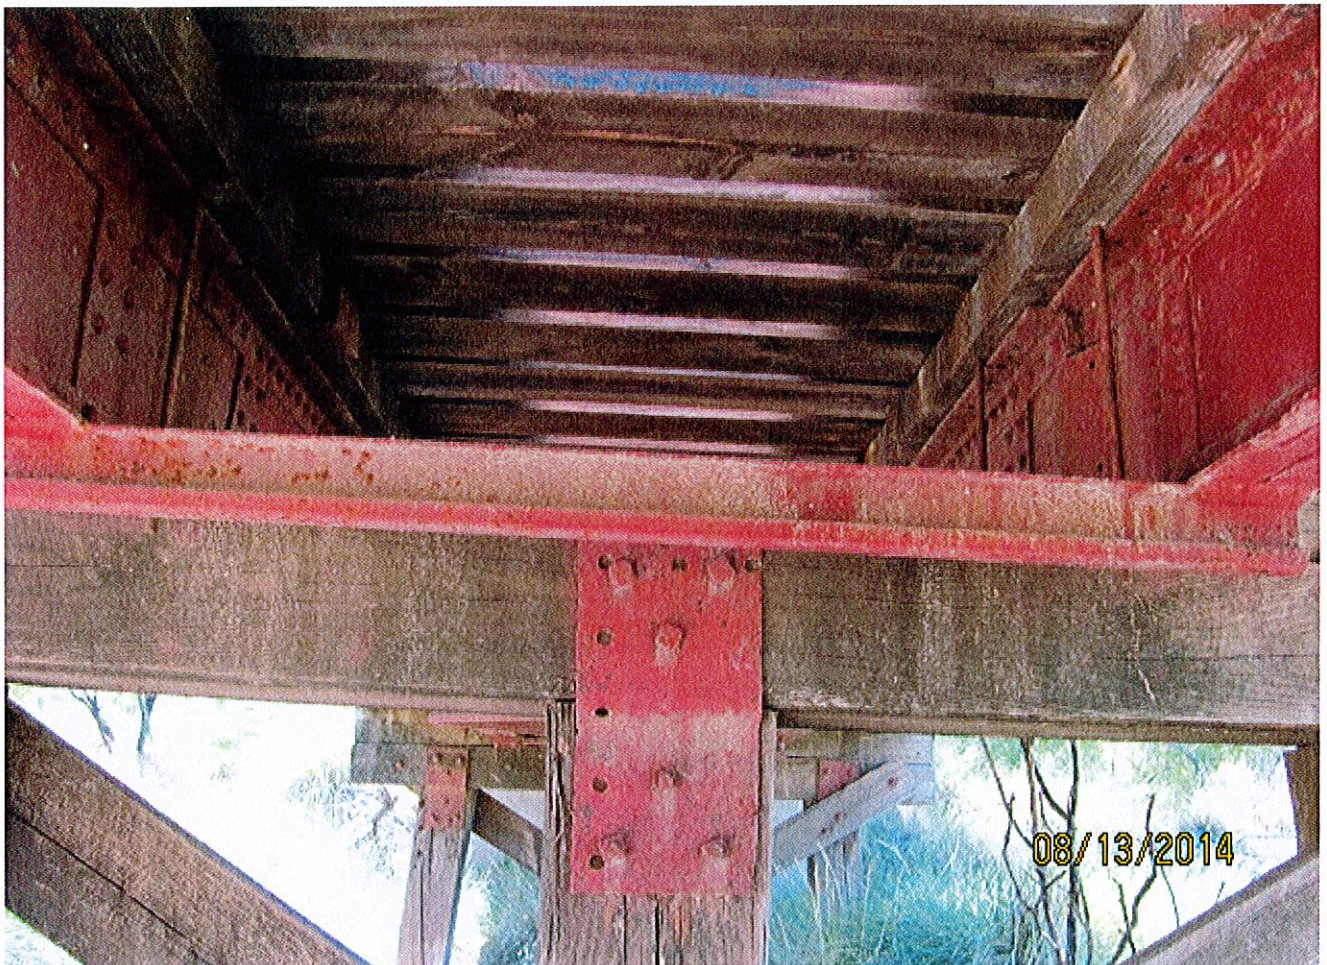
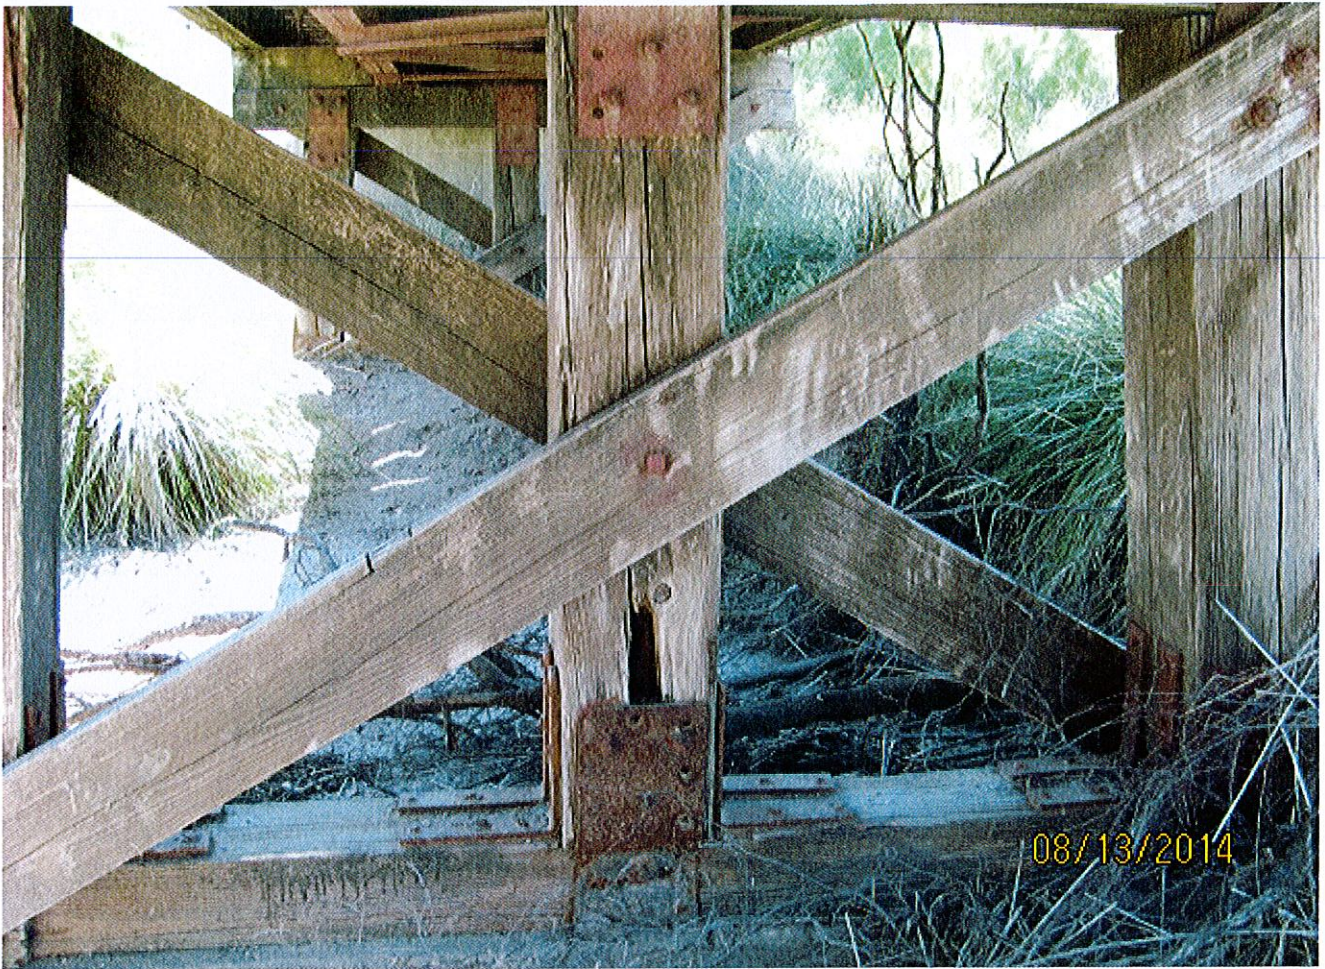
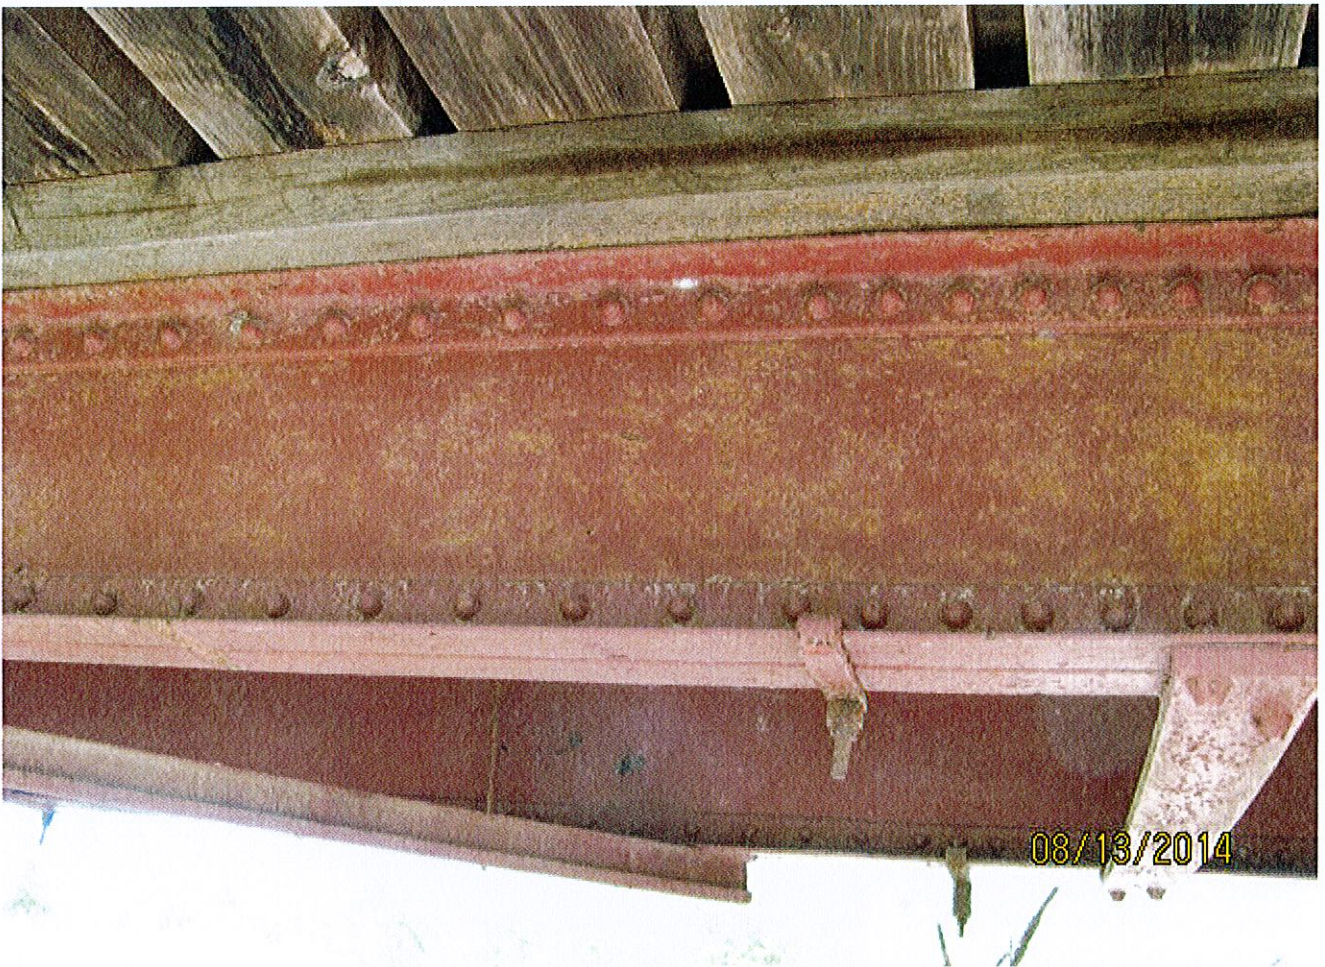
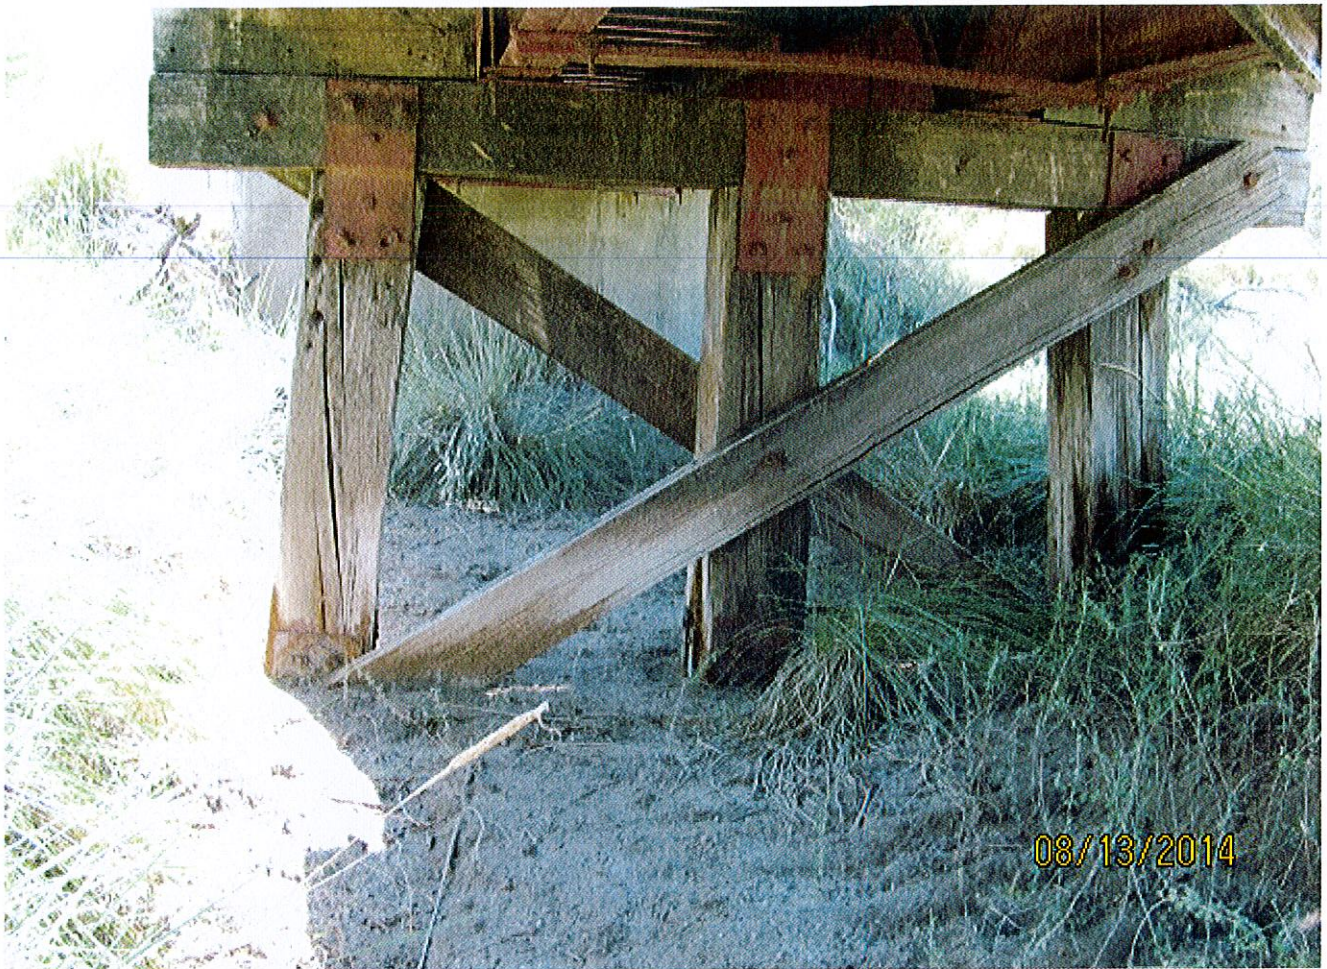
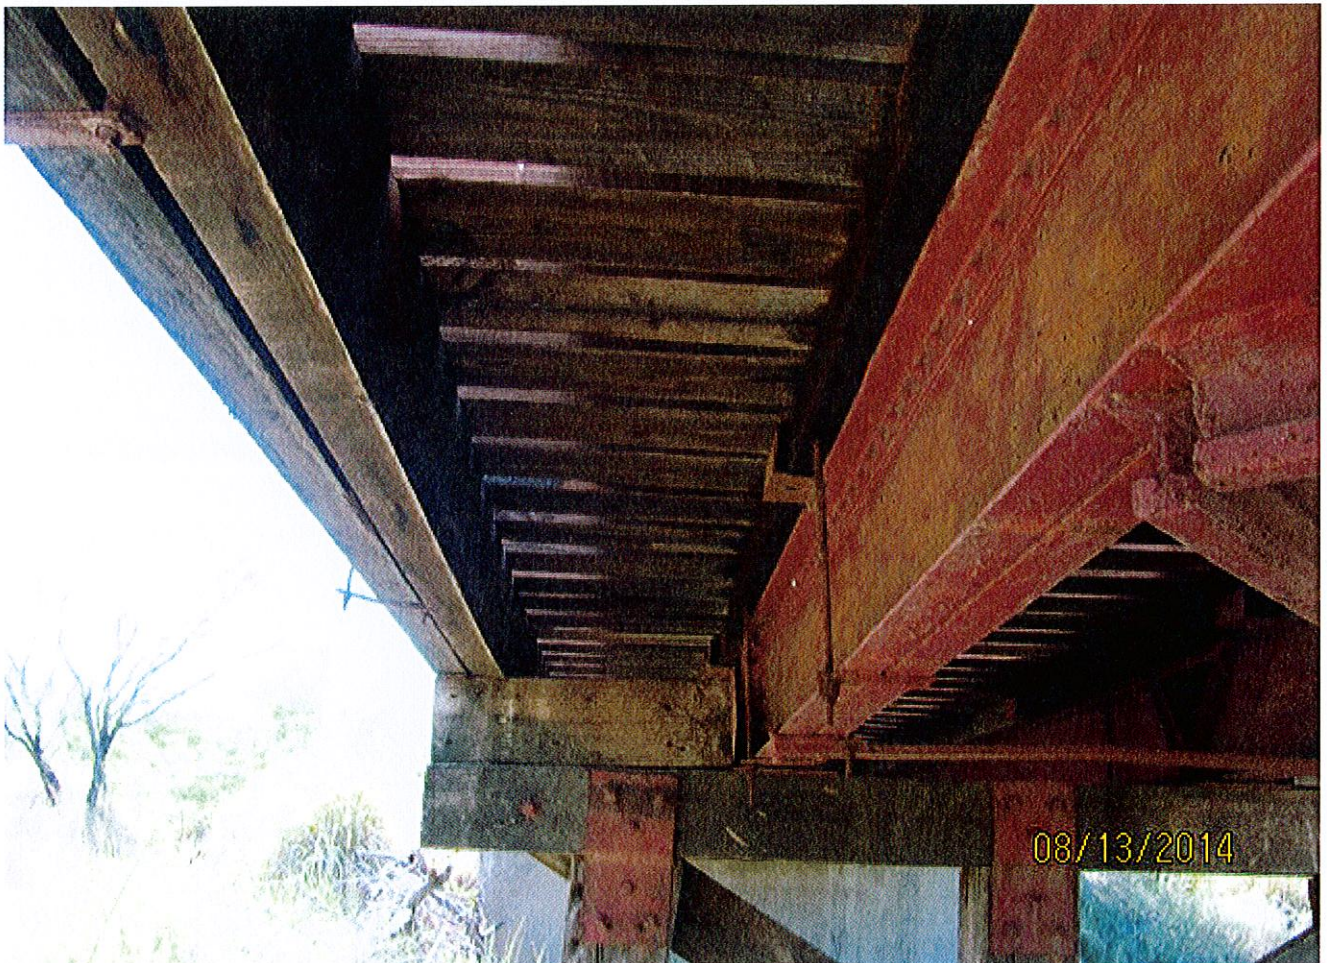
Wooden support beams show signs of wear and tear, cracking, loose bolts, nails are exposed and some guide rails are loose.

Steele beams show some rust and need paint.

Concrete has some chipping/cracking where the structures meet.

Undergrowth on both side of the bridge and there is some soil build-up on both sides.
